## Assessment Report

Document No.: (5261/998/14b) – Pan of 31/10/2014

Subject: Penetration elements/tie provided with BeSealed UFO sealing plug capable of swelling in water to be tested for water tightness, in structural elements made from concrete with a high water penetration resistance

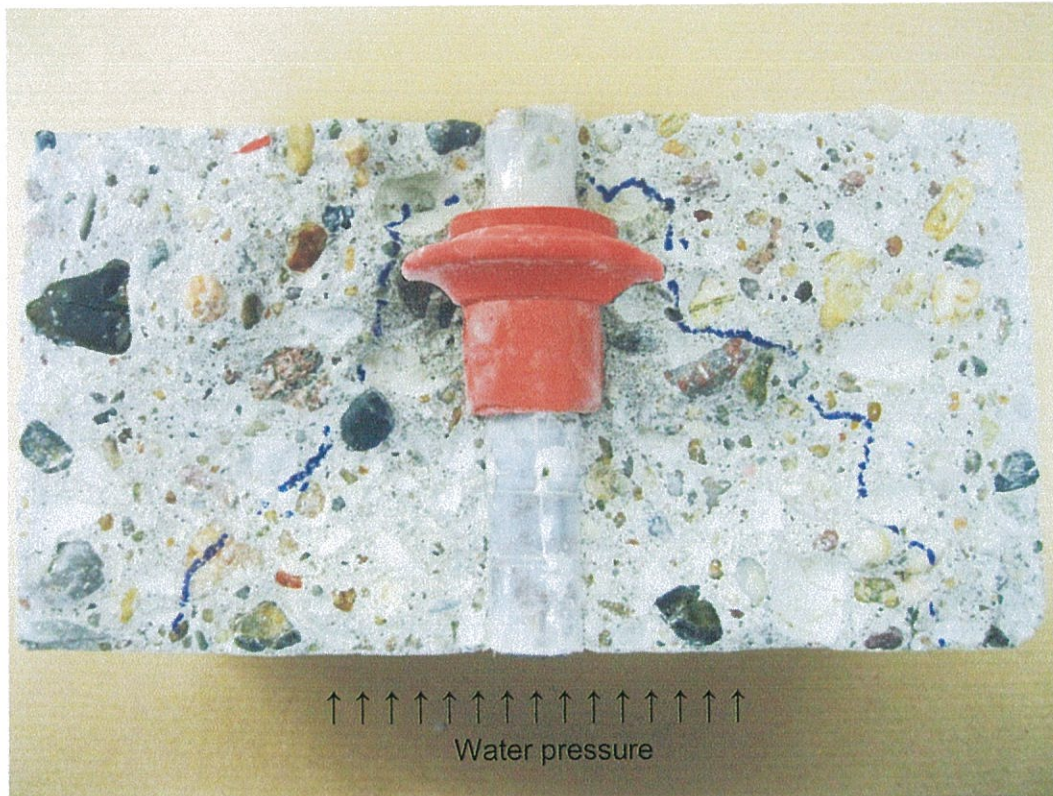
**Fig. A2:** Sample 1: anchor rod (ribbed steel  $\varnothing = 16$  mm)

- Sample 1: anchor rod (ribbed steel,  $\varnothing = 16$  mm) with "BeSealed Sealing Connector" sealing collar ( $\varnothing_{\text{inside}} = 16$  mm,  $\varnothing_{\text{outside}} = \text{approx. } 24$  mm, depth = 36 mm)

After the test for tightness, the samples were split in the middle, and the depth of water penetration was recorded (photos A2 to A5).

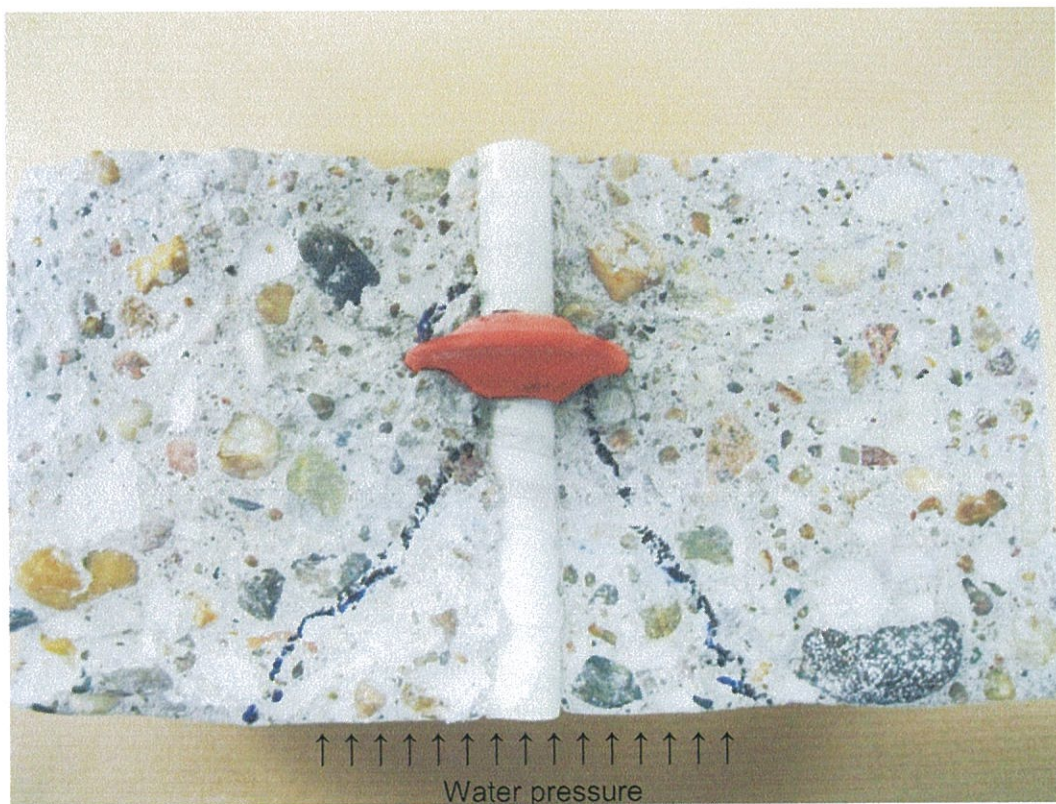
**Fig. A3:** Sample 2: glass-fibre rod (ribbed  $\varnothing = 14$  mm)

- Sample 2: glass-fibre rod (ribbed;  $\varnothing = 14$  mm) with "BeSealed Sealing UFO" sealing flange ( $\varnothing_{\text{inside}} = 12$  mm,  $\varnothing_{\text{outside}} = \text{approx. } 40$  mm, depth = 15 mm)

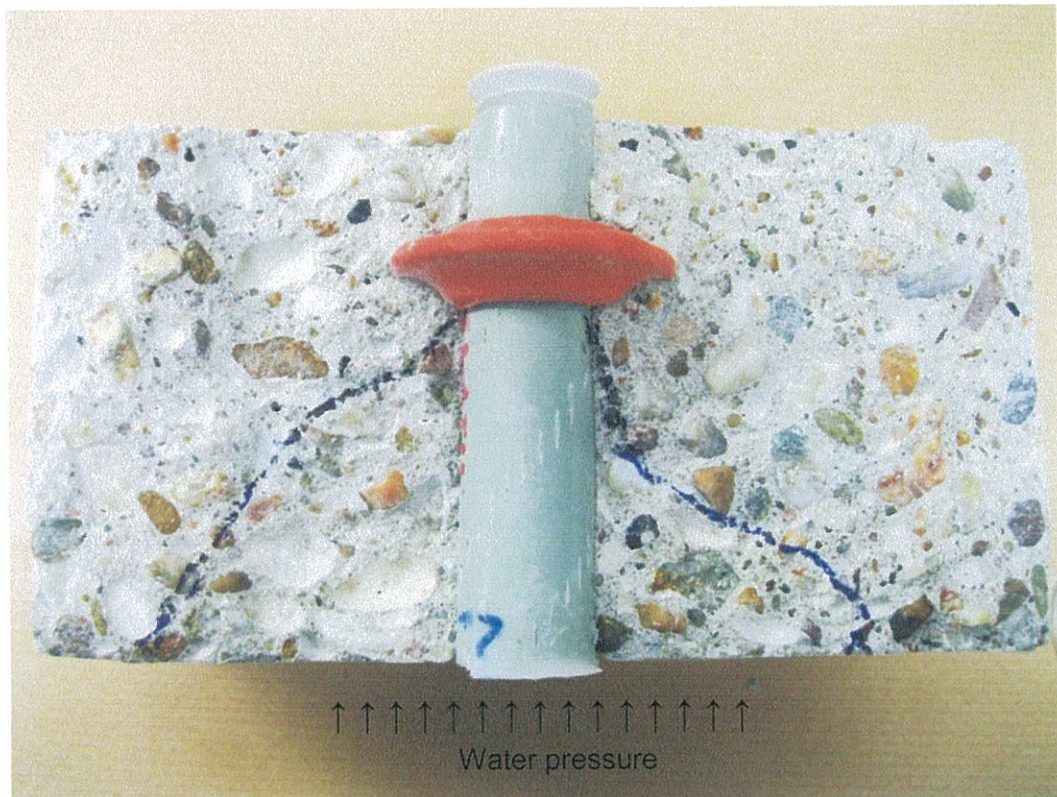
**Fig. A5:** Sample 4: plastic pipe ( $\varnothing_{\text{inside}} = 22 \text{ mm}$ ,  $\varnothing_{\text{outside}} = 26 \text{ mm}$ ); negative water pressure acting on the plug

- Sample 4: same as series 3; test with negative water pressure acting on the plug
